CORPS OF ENGINEERS STATIC AIR PRESSURE TEST REPORT

Specimen tested: Stand'N Seam panels
Specimen properties: 24 ga., grade C galvanized steel
Type of test: wind uplift

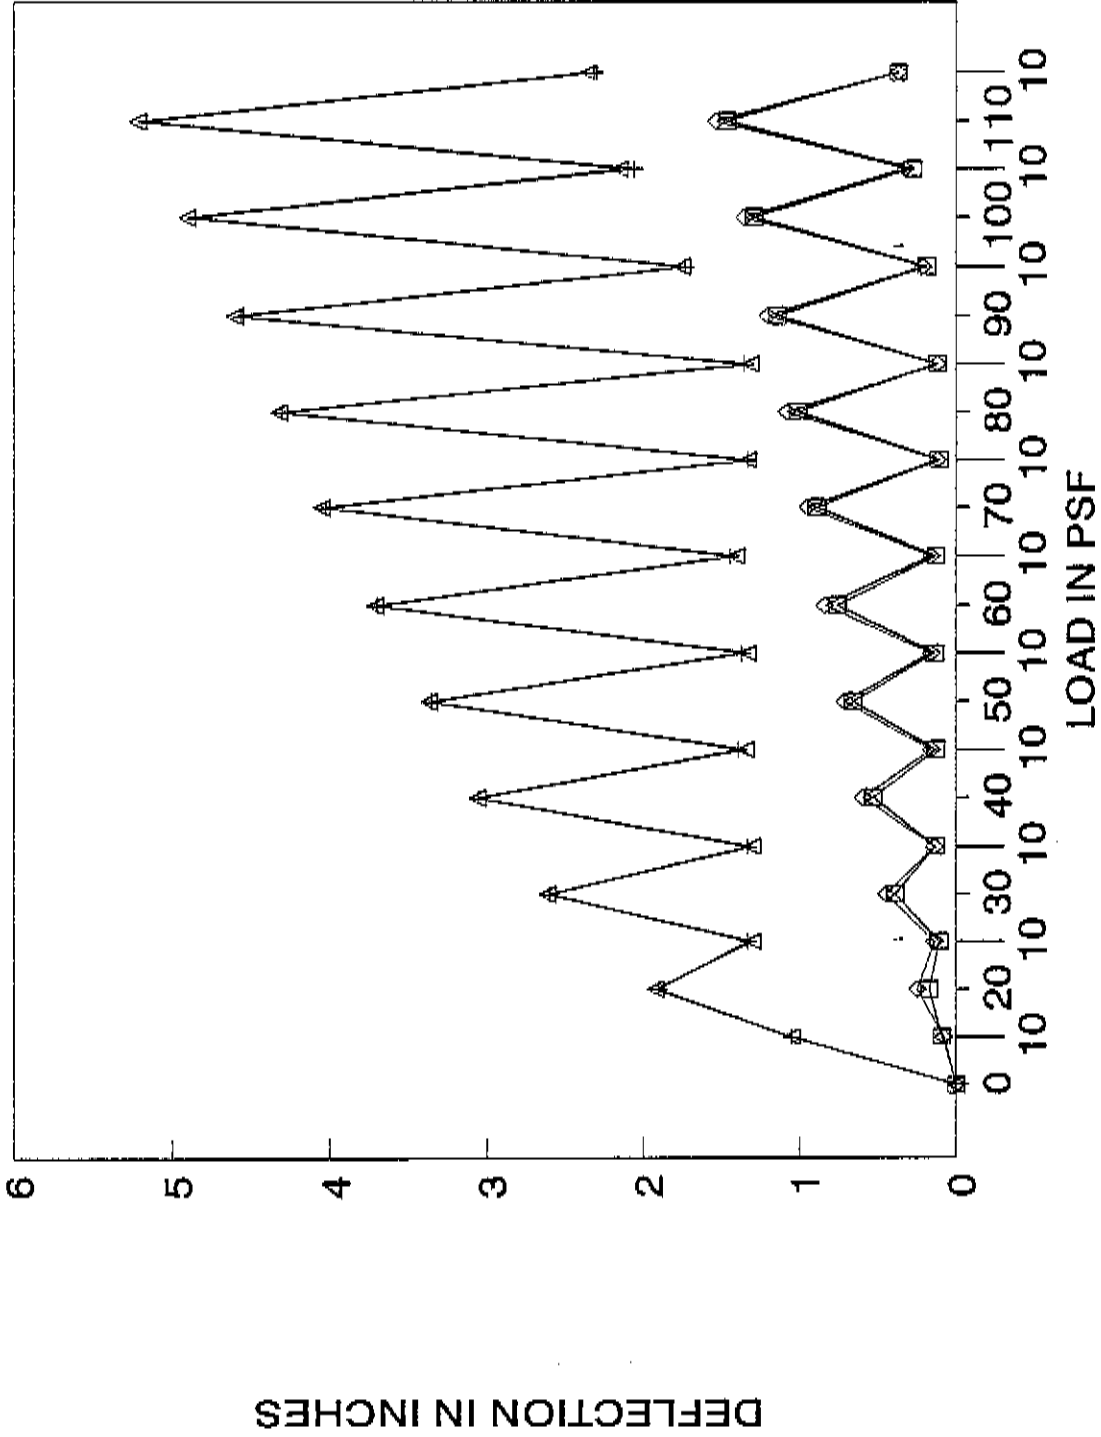
Corps of Engineers Test 7/30/93

The deflections are shown in the data sheet and are shown in two attached graphs. The graphs show that the pan deflection was almost identical at the support and at midspan.

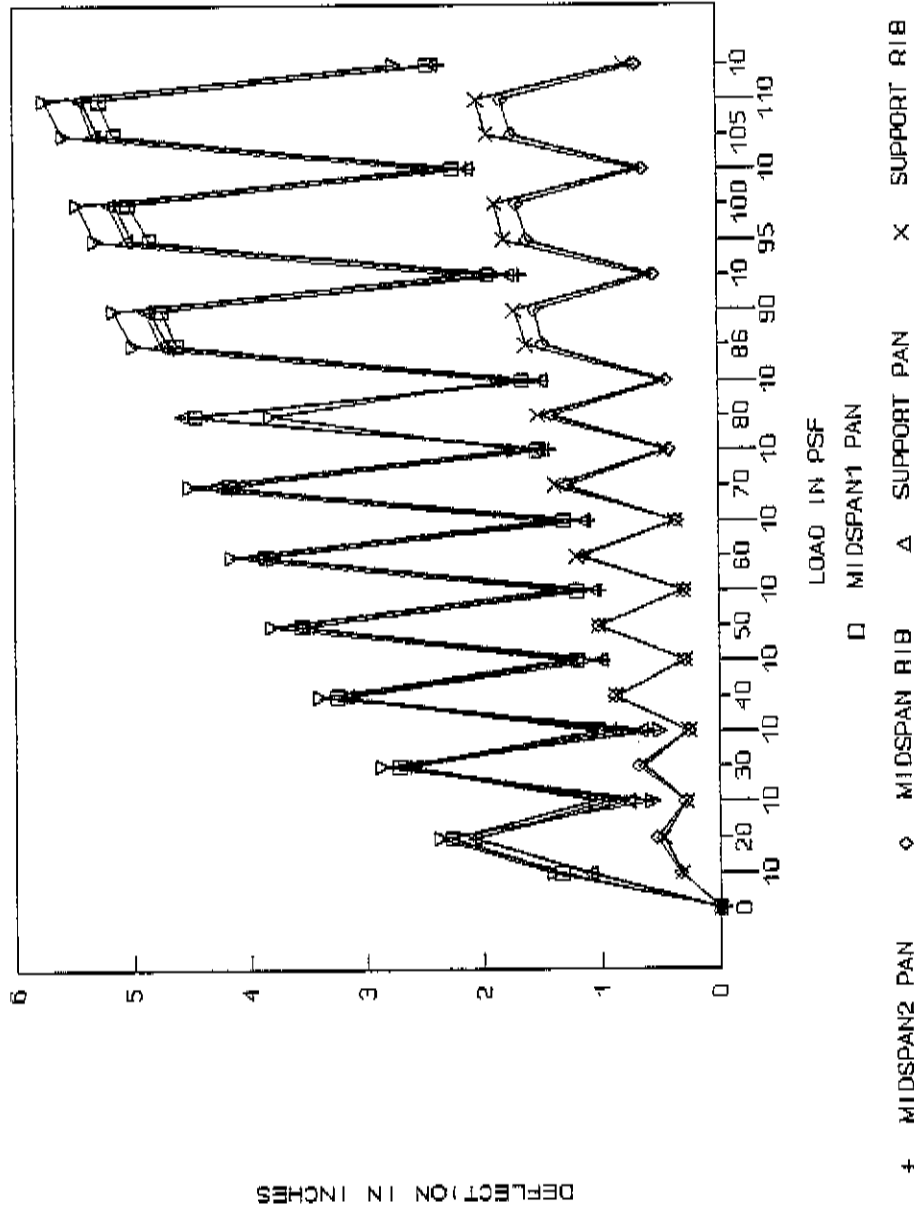
Actual deflection readings

The deflections are shown in the data sheet and are shown in two attached graphs. The graphs show that the pan deflection was almost identical at the support and at midspan. It should be noted that deflection reading #6 at the 80 psf load appears out of place. It is assumed that the deflection gage was misread.
