## ASTM E 1592 STATIC AIR PRESSURE TEST REPORT

Specimen tested: 18" wide Thin Seam panels

Type of test: **WIND UPLIFT PER ASTM E 1592**

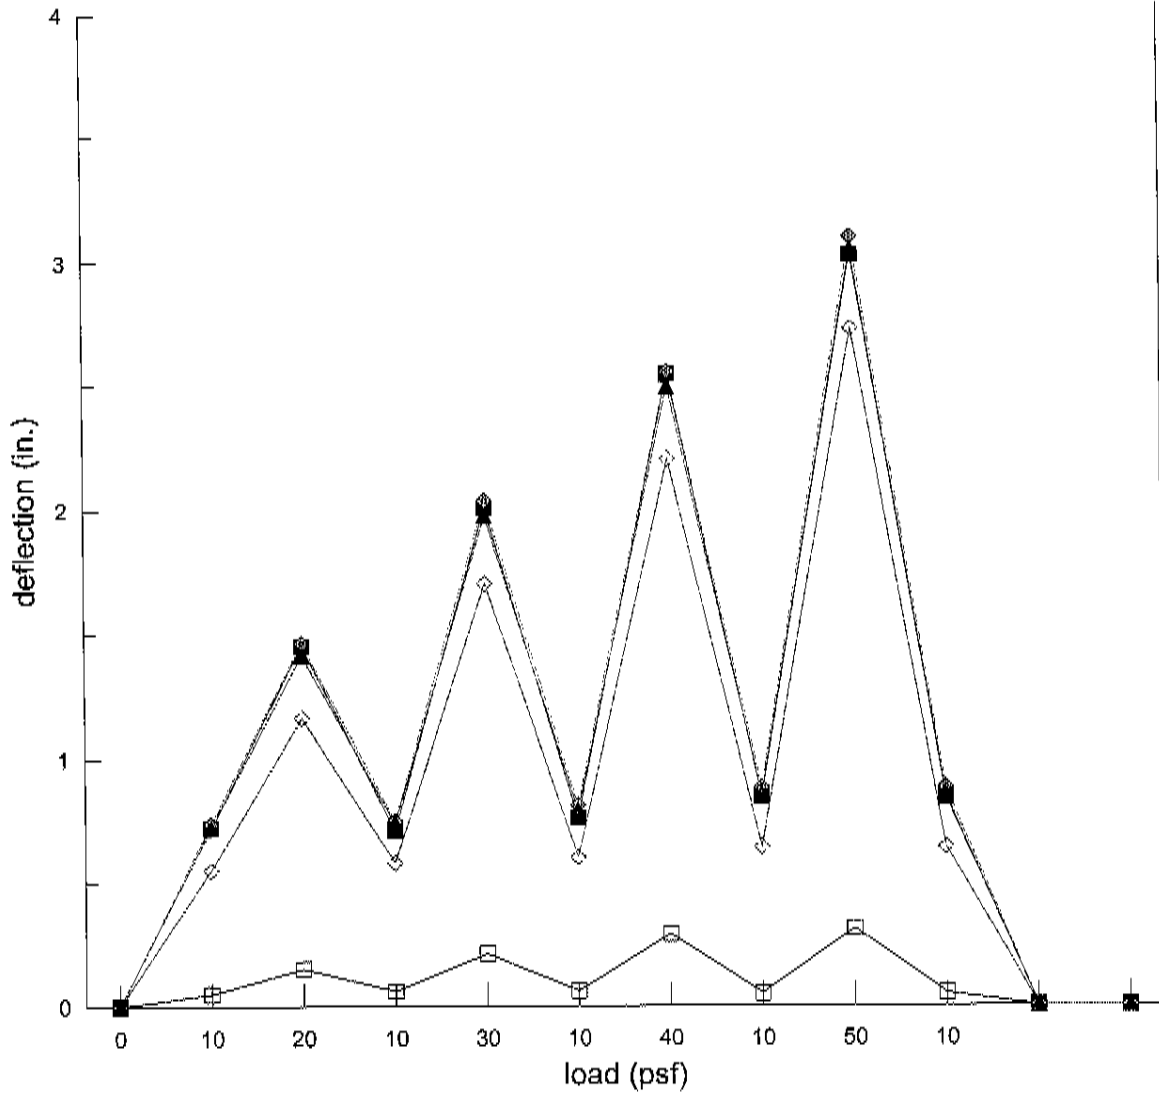
Load vs. deflection for 24 ga. Thin Seam panels' static air pressure test as per Corp of Engineers (spacing is 2'-6")

A maximum air pressure of 50 psf was attained before panel failure occurred in the sidejoint. Sidejoint failure occurred during an attempt to load the panels to 60 psf. Failure occurred as the sidejoint yielded sideways, effectively "unsnapping" the snap-together seams.

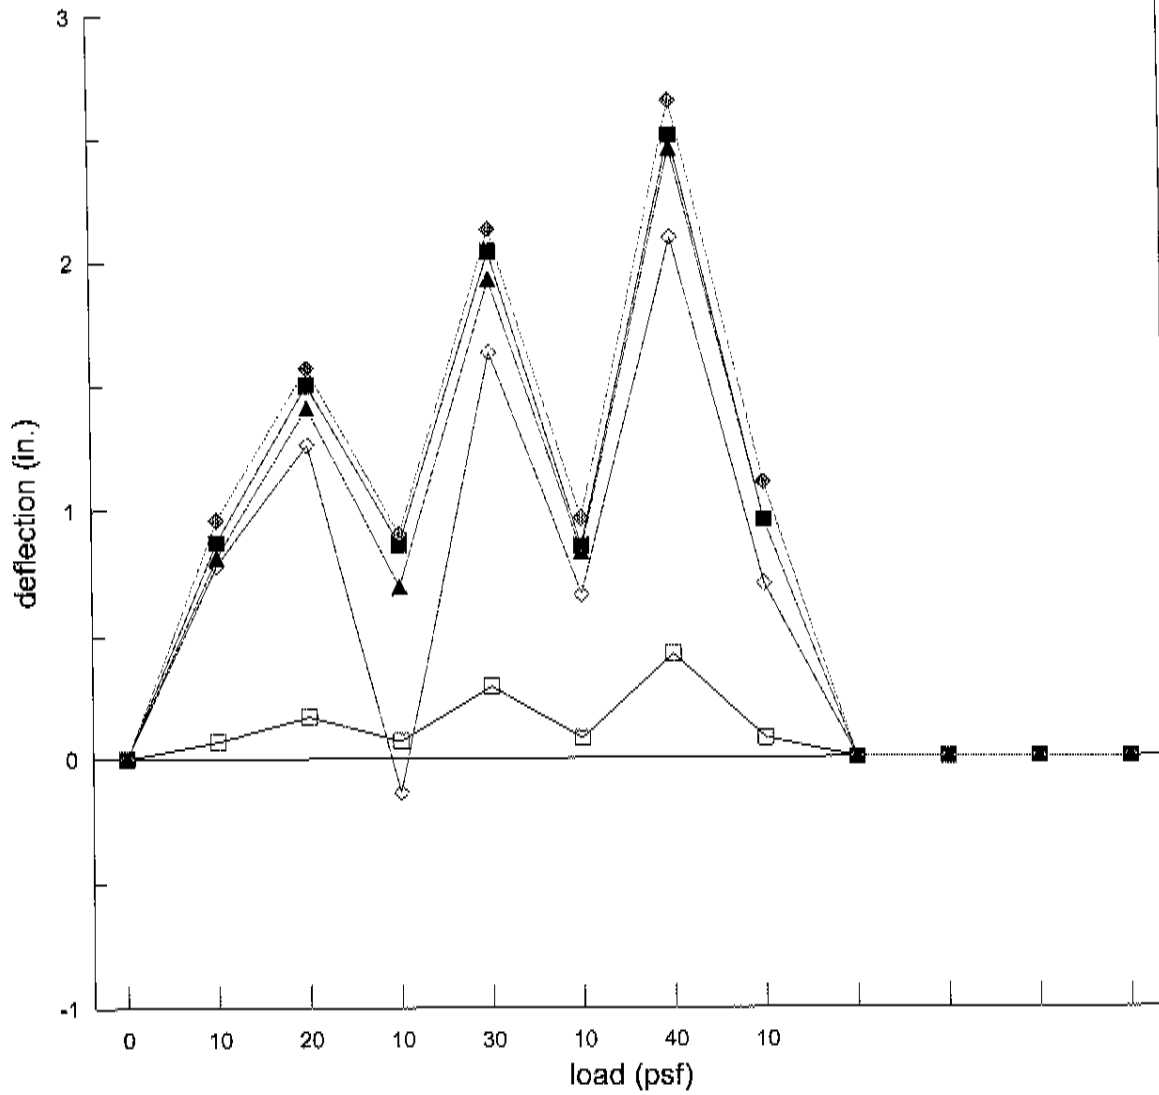
Load vs. deflection for 24 ga. Thin Seam panels' static air pressure test as per Corp of Engineers (spacing is 5'-0")

A maximum air pressure of 49 psf was attained before panel failure occurred in the sidejoint. Sidejoint failure occurred during an attempt to load the panels to 50 psf.

Failure occurred as the sidejoint yielded sideways, effectively "unsnapping" the snap-together seams. Four sidejoints yielded simultaneously at 49 psf.
