CORPS OF ENGINEERS STATIC AIR PRESSURE TEST REPORT

Specimen tested: Stand'N Seam panels
Specimen properties: 24 ga., grade C galvanized steel
Type of test: wind uplift

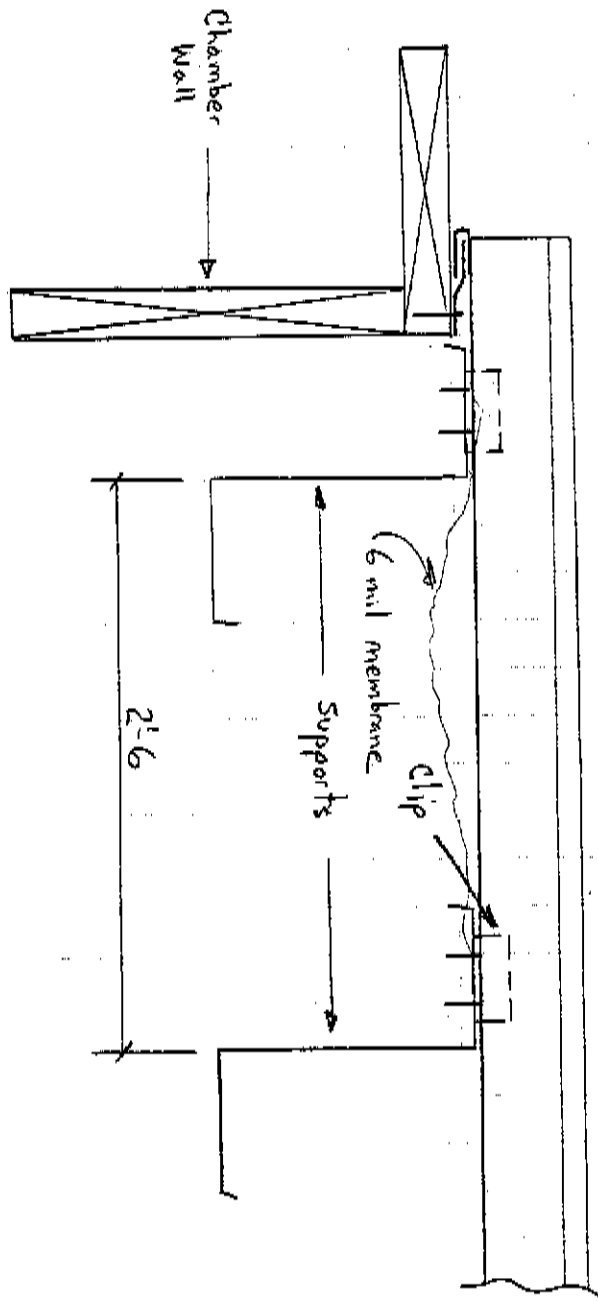
NAME: **FREE END DETAIL**

- 120 psf on the way to the 120 psf load, the plastic had ripped so badly at the free end (opposite the eave end) that adequate pressure could not be maintained. In an effort to reseal the plastic, three screws per panel pan were installed in the free end to reseal the tears. Also, one screw was installed in the free end of the eave cleat, since this condition does not occur on a building and because the plastic was tearing.

FREE END SCREWED DOWN WITH 3 SCREWS PER PANEL TO SEAL. ALSO 1 SCREW WAS ADDED AT END OF CLEFT ON FREE END.
Failure at 158 psf
