CLIENT: Atlanta Metal Products, Inc.
5700 Riverview Industrial Drive
Mableton, Georgia 30059

MATERIALS: A roof test section was mounted to the top face of a 8' x 10' x 30" test chamber, located at the Knudson Mfg. facility in Broomfield, Colorado.

The roof assembly specifications are as follows:

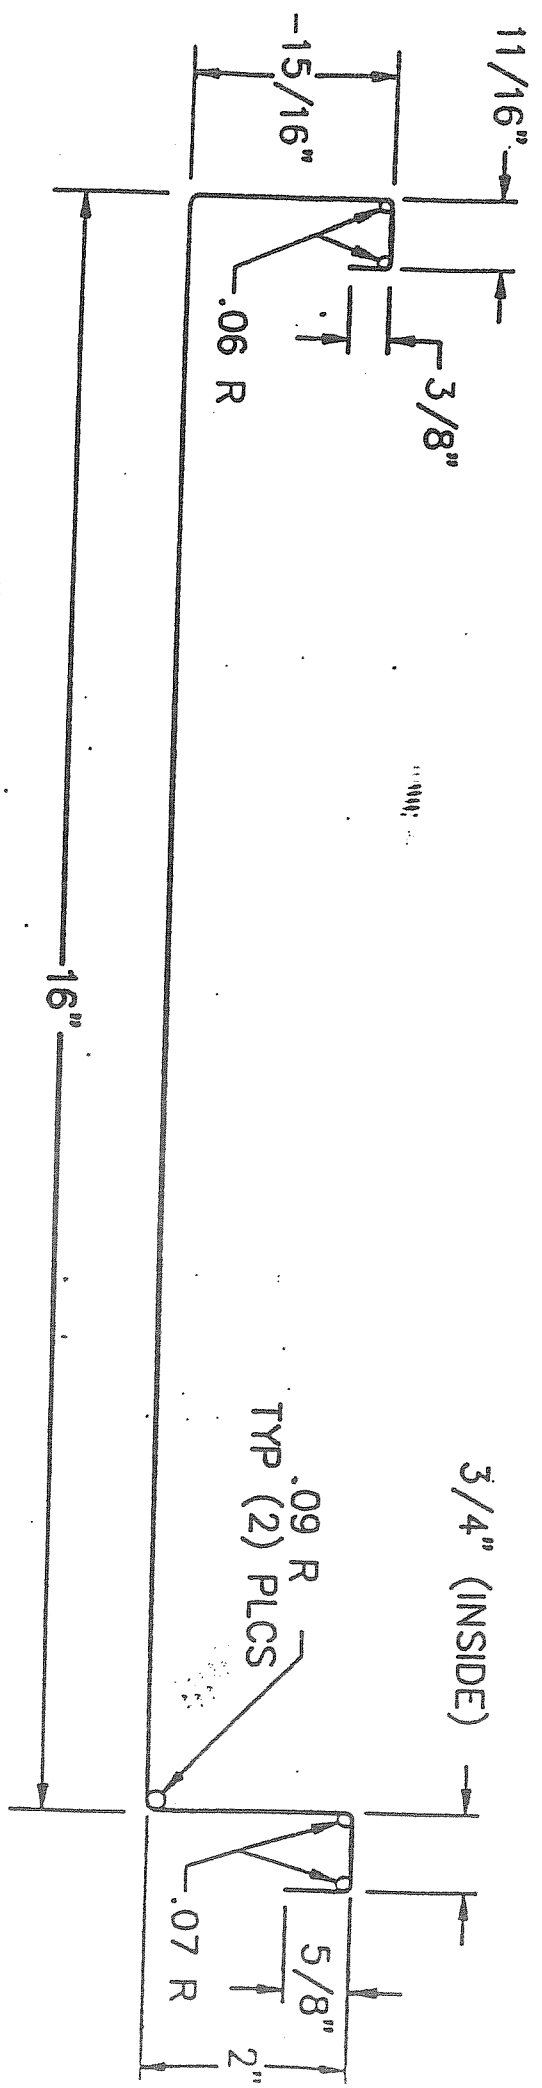
"AMP LOK"

SCALE 2:1

MIN. YIELD STRENGTH
50,000 P.S.I.

NOTE: ±10% ON ALL DIMENSIONS

1. Roof Panels - 16 in., 24 ga "AMP Lok", 2 in. standing 45° bend seam, hot dipped galvalum surface treatment as identified by the client. Panel sheet thickness was measured to be 0.026 in. A drawing of the panel profile is presented as Figure 1.
2. Purlins - Metal Sales 16 ga., 8", "Z" purlins mounted on a 5' center spaced centrally to the 8' dimension of the test chamber. The purlins were mounted $\frac{3}{8}$ in. lower than the edge of the test chamber to accommodate the thickness of the clips used so that the panels would mount flush with the chamber. Purlin steel thickness was measured to be 0.067 in.
3. Clips - "CFI" 2 screw clips mounted one clip per seam per purlin. Drawings of the clip are presented in Figure 2.
4. Clip screws - Alliance Fastening Systems, Inc. #12 x $\frac{3}{4}$ HWH self drilling screws.

5. Sealant - A $\frac{1}{4}$ " diameter (approximate) bead of SikaCalk® 501 Sealant was extruded into the entire length of the female bend of the panel during the formation of the panel profile (ref. Figure 1).

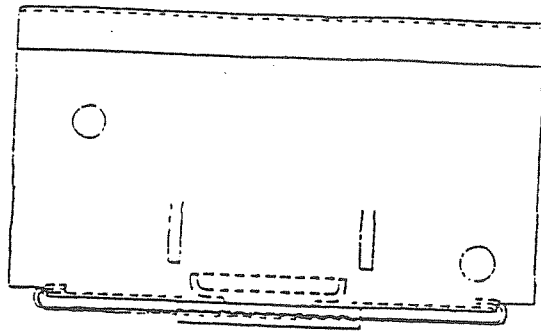
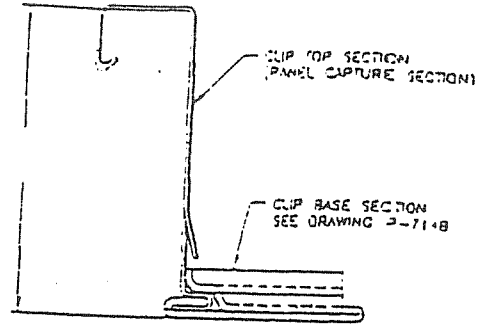
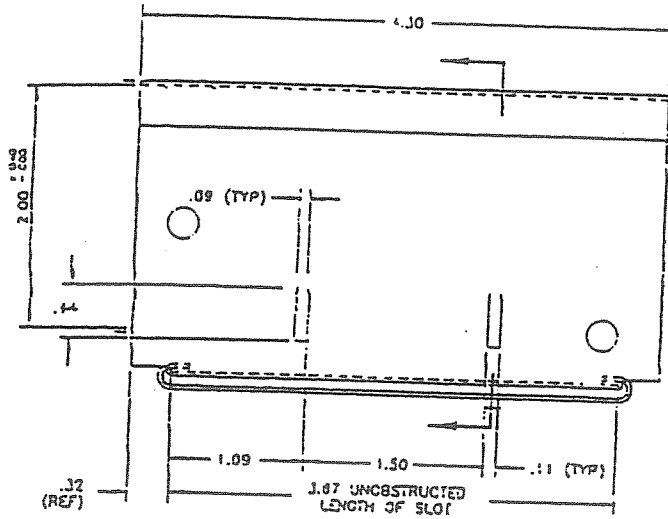
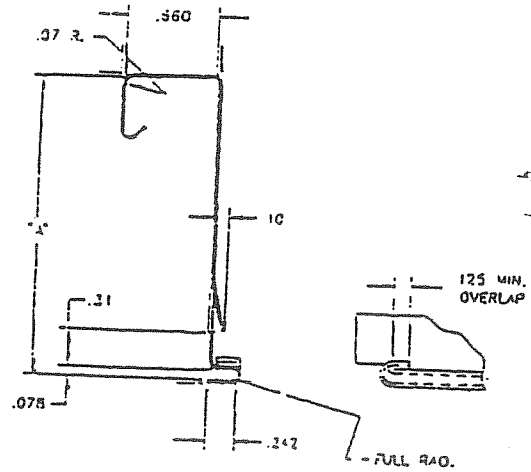
- NOTES:
 1. MATERIAL: G-90 GALVANIZED STEEL - PLAIN FINISH. 33 TO 50 KSI YIELD PER WPS-008, .030 TO .034 THICK.
 2. FOR BASE DETAILS, SEE DRAWING P-7148
 3. ALL RADII TO BE .040 UNLESS NOTED
